# LAKE BRAZOS DAM

## ENGINEERING SERVICES

Presentation to City Council

November 19, 2019

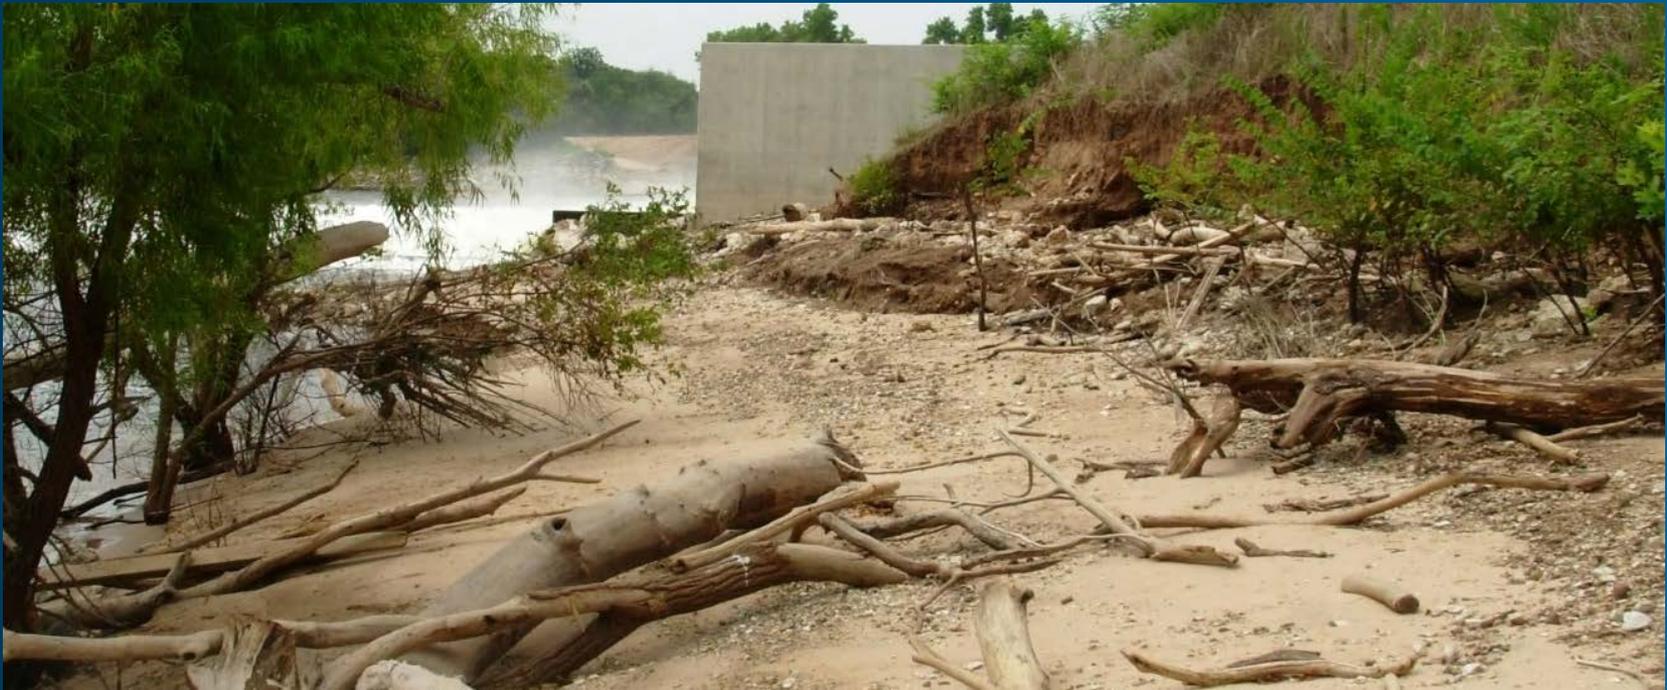
- 2004: Observations of steep slope and poor condition of sheetpile. Prepared stilling basin design.
- 2007: Flooding during construction damaged slope
- 2007: TCEQ recommended monitoring until permanent repair is implemented

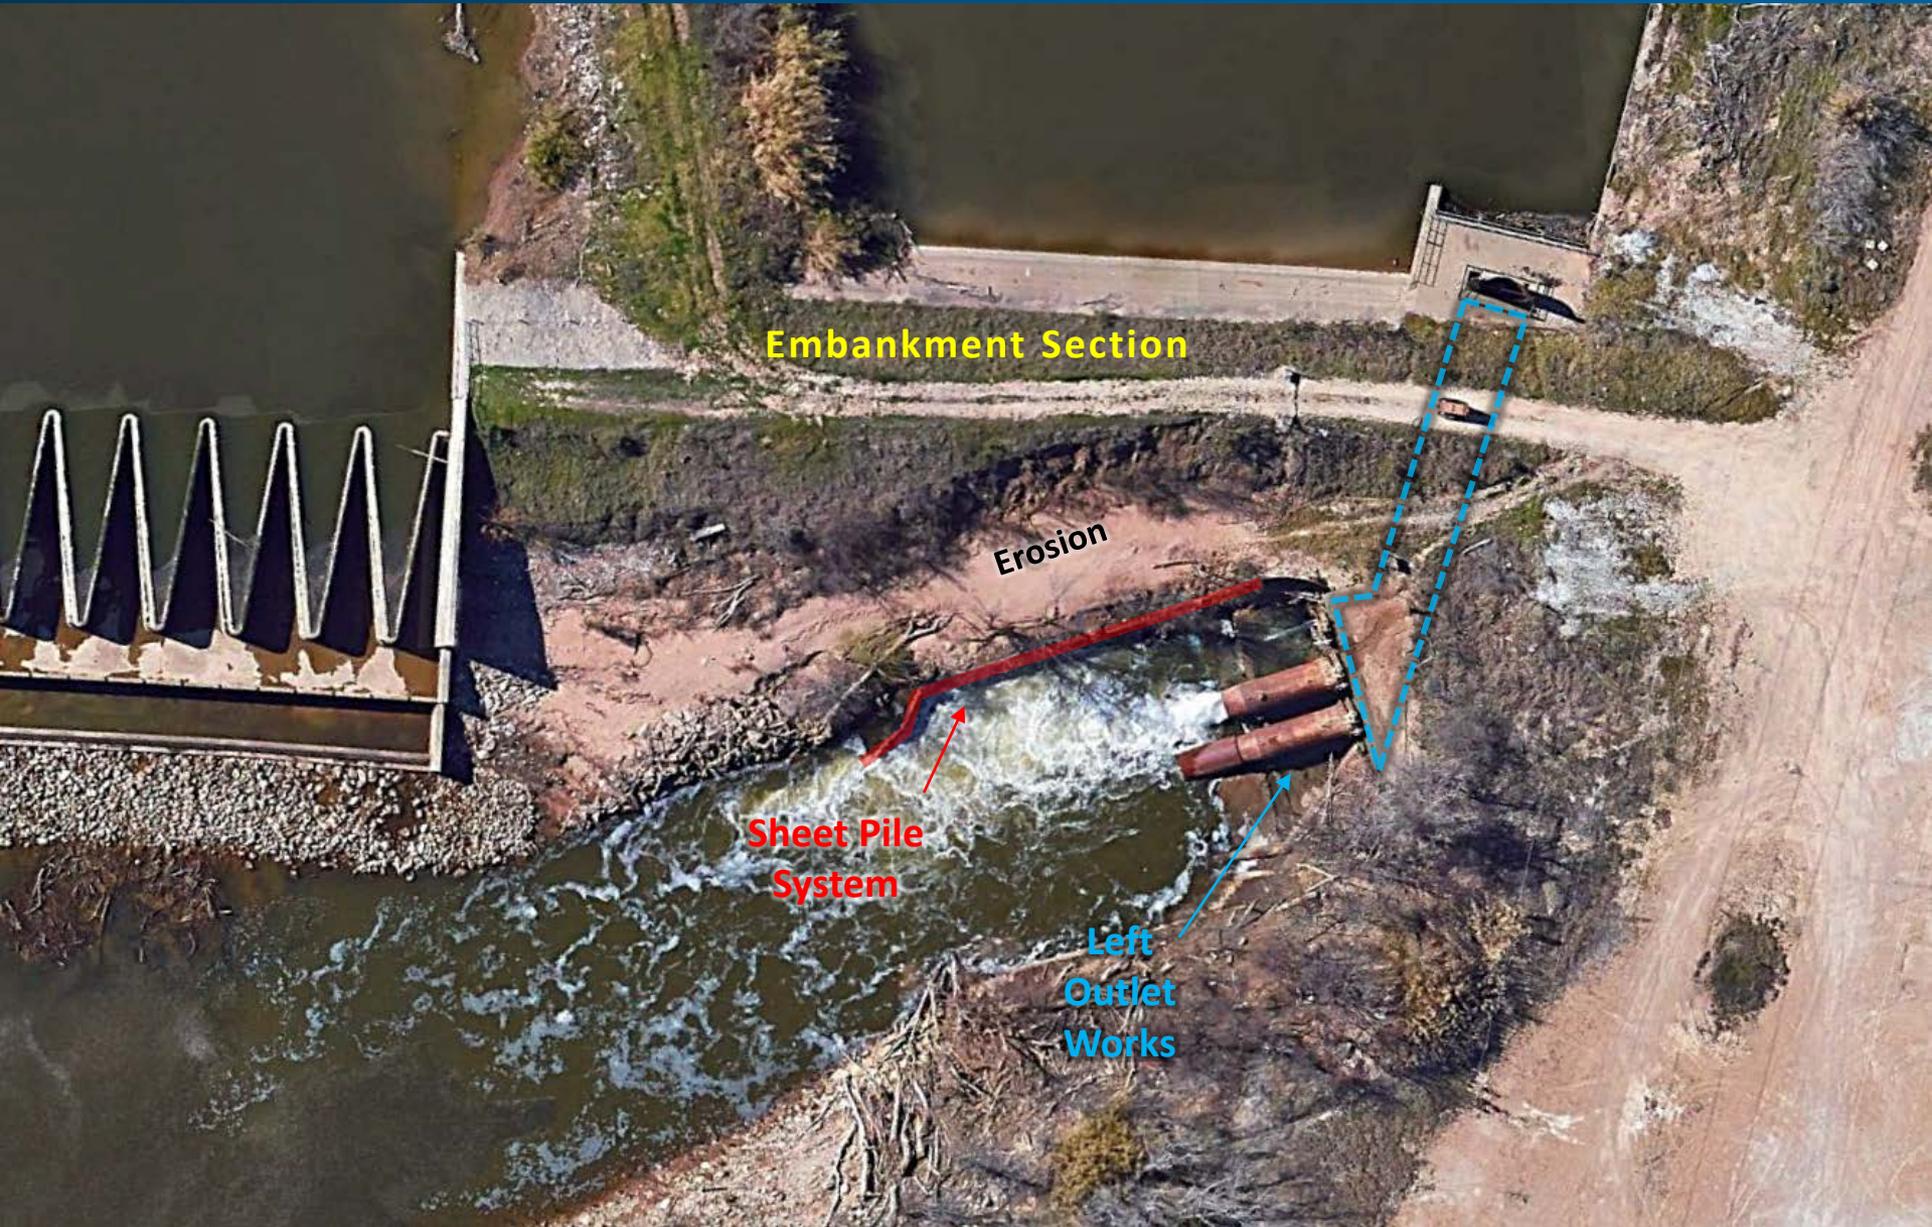
Embankment Section

Erosion

Sheet Pile System

Left Outlet Works

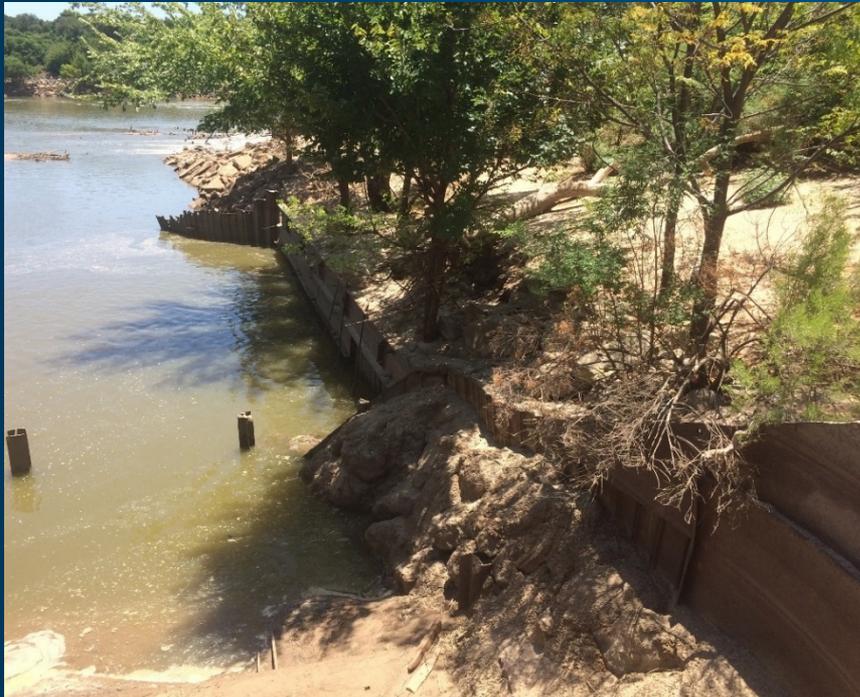
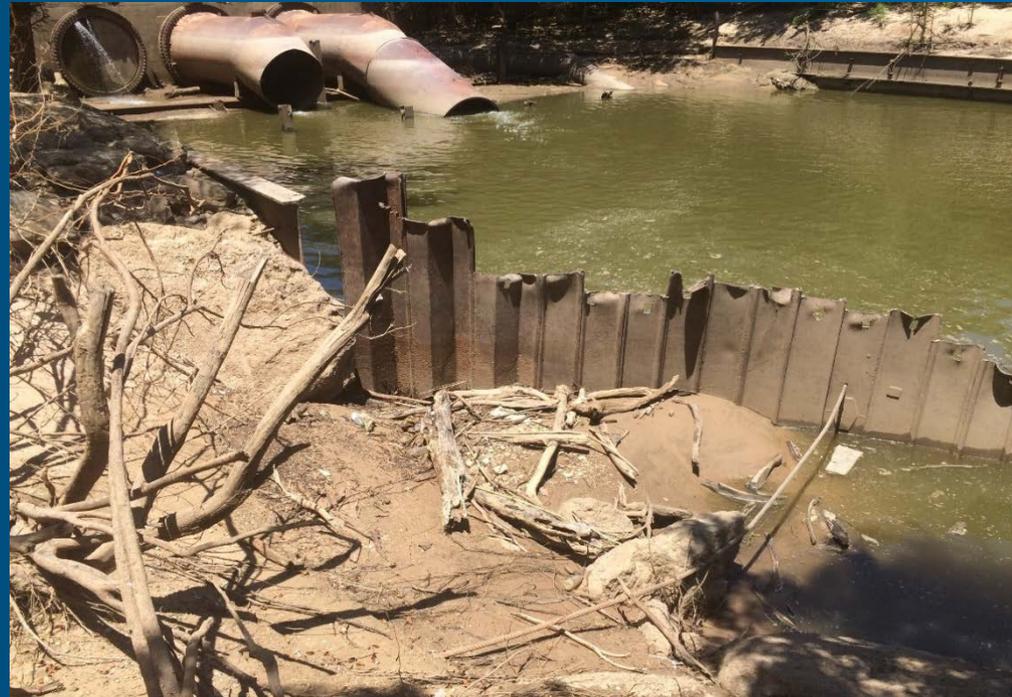
- 2014: Existing sheetpile condition noted to be worsening
- 2016: FNI evaluated the existing condition of the embankment and earth retaining system

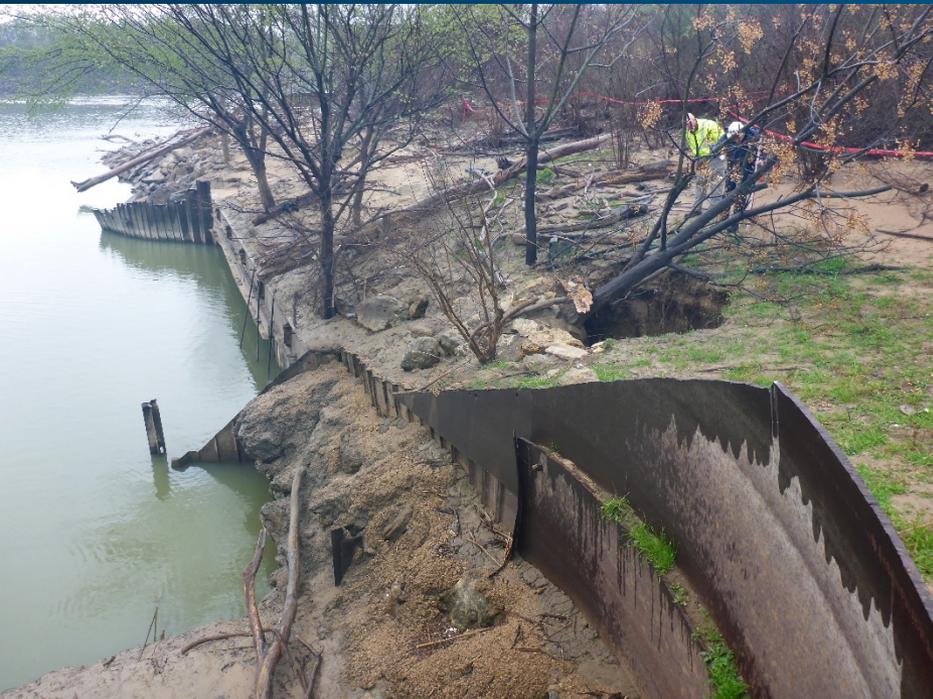
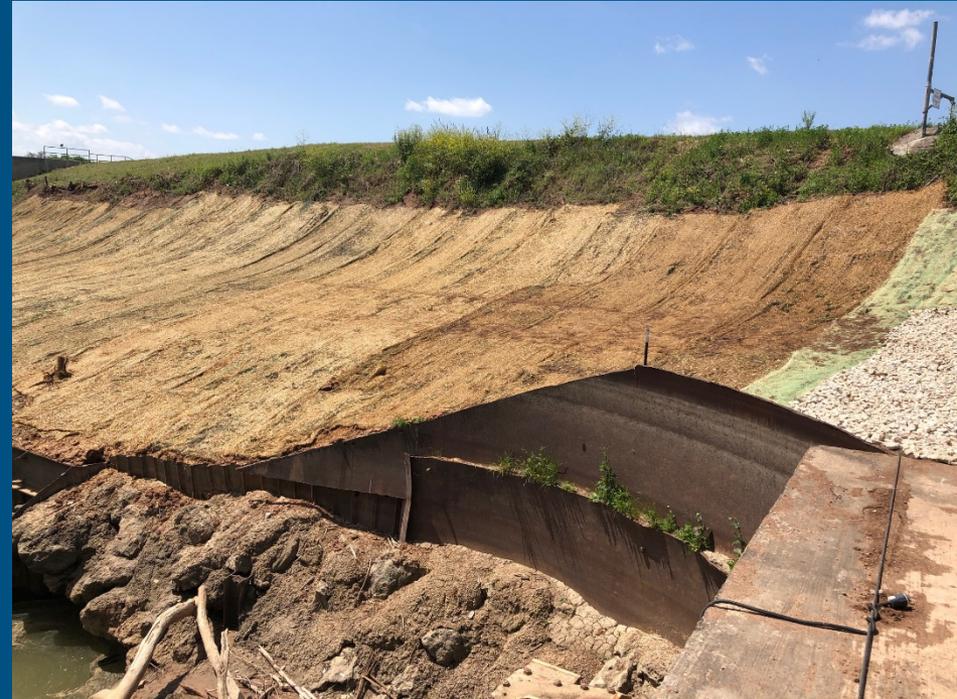
- 2019: City made temporary repairs to the worsening condition (sinkhole) of the embankment toe

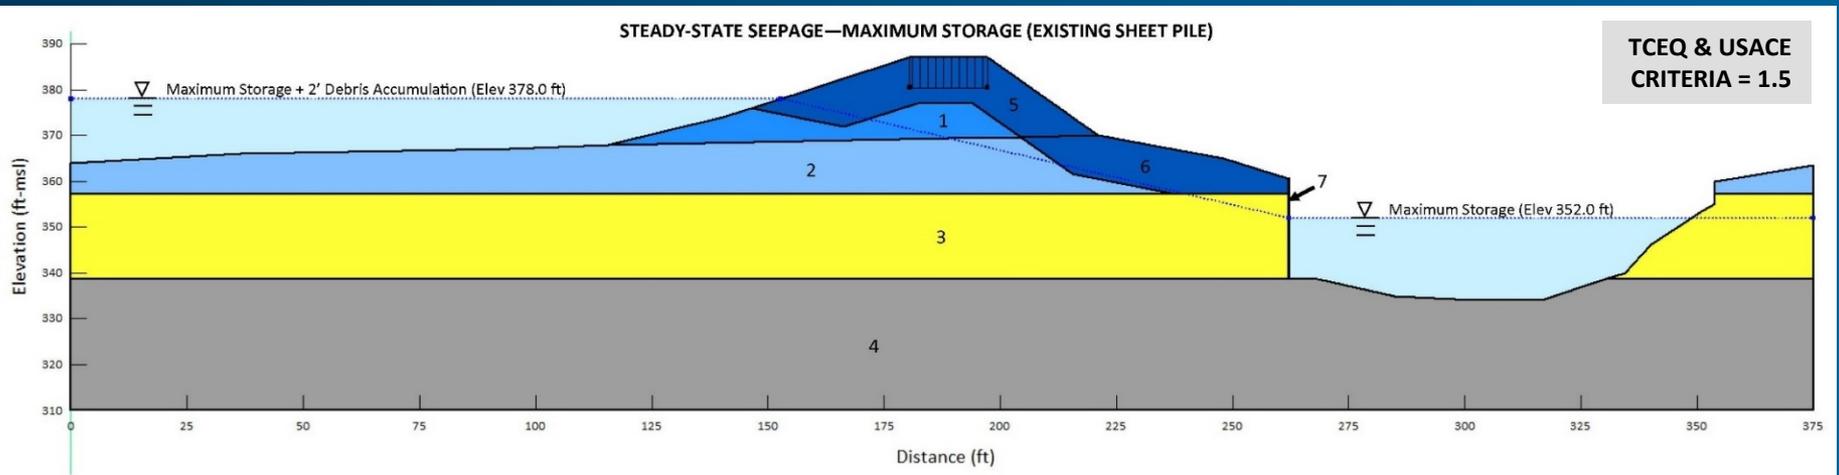
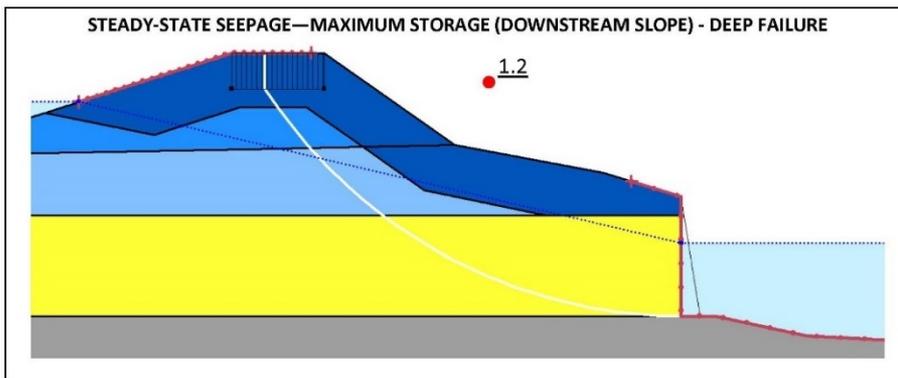
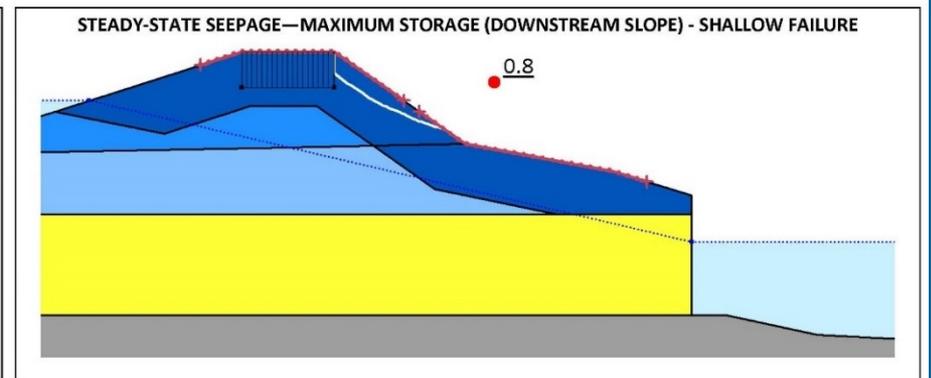
- Embankment downstream slope stability does not meet recommended safety factors
