# LAKE BRAZOS DAM

## ENGINEERING SERVICES

Presentation to City Council

August 16, 2022

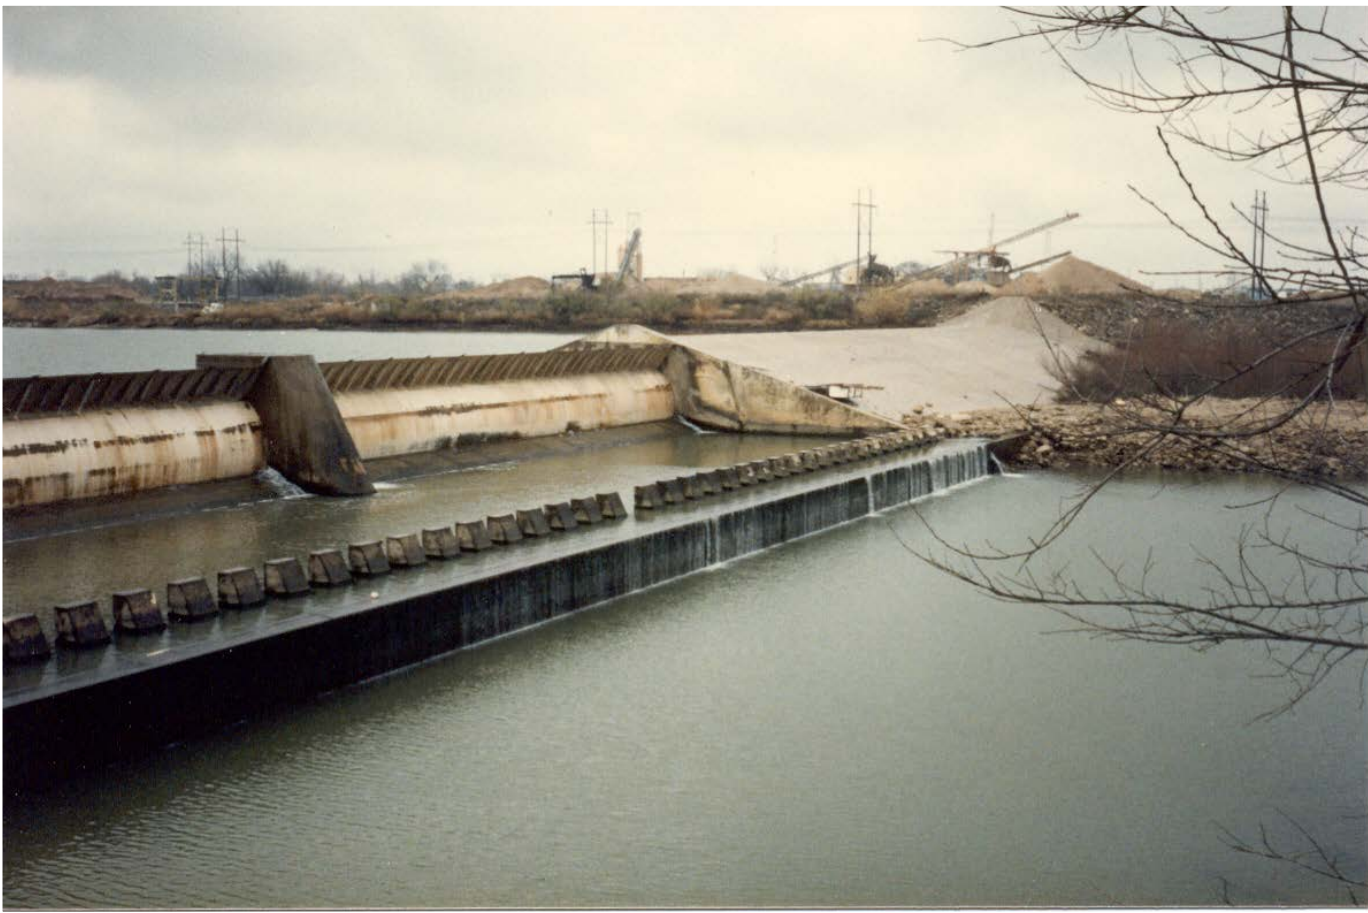
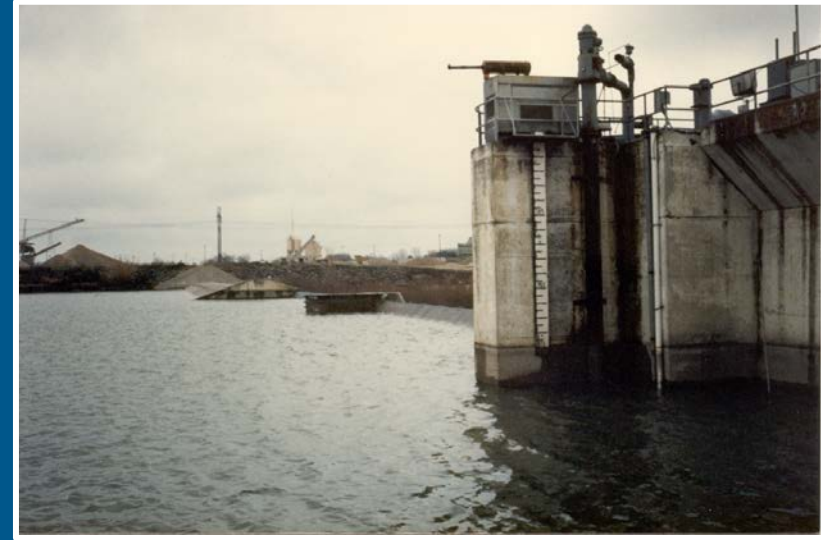
- Constructed in 1970
- Gated Spillway with Concrete-lined Embankment

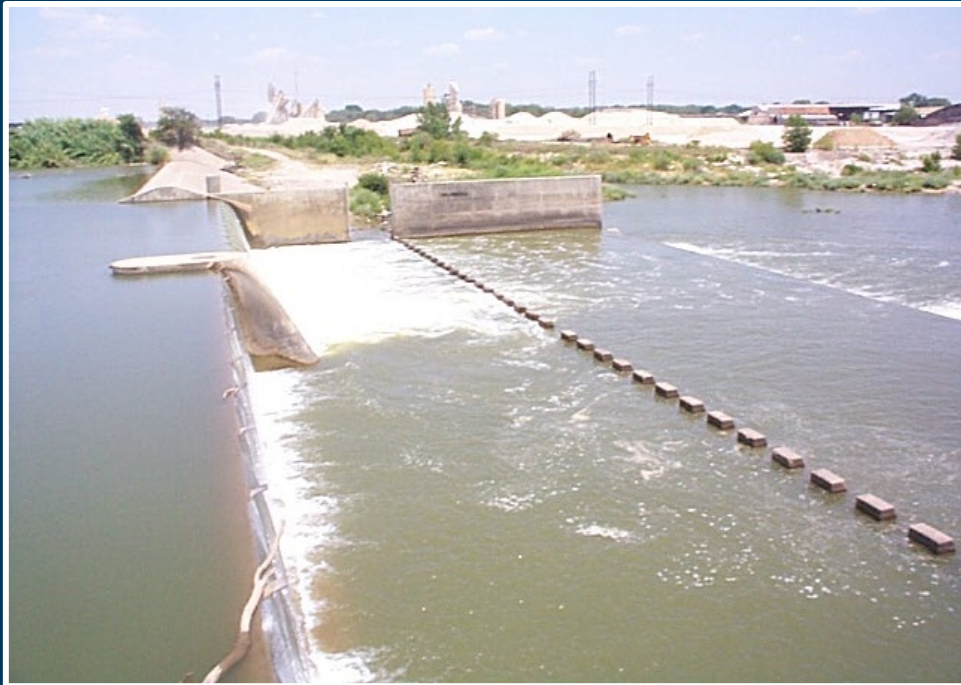
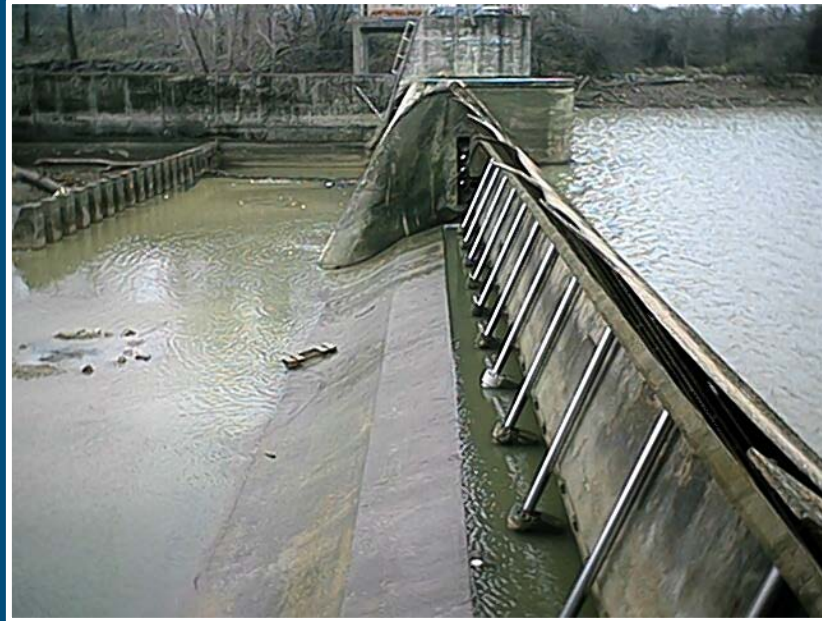
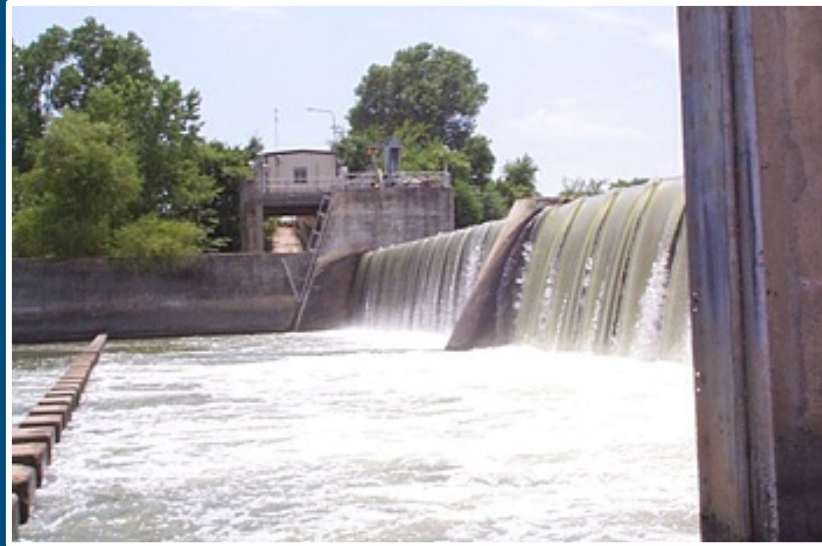
- Gates replaced in 1985 with Hydraulic Leaf Gates
- Extended Stilling Basin

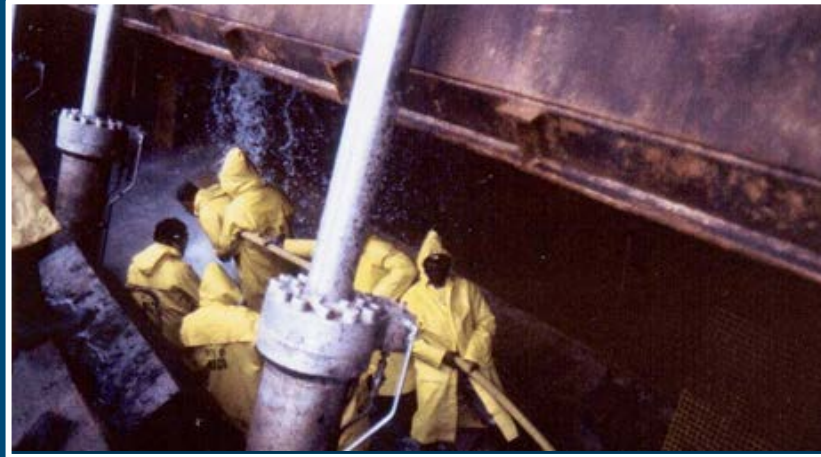
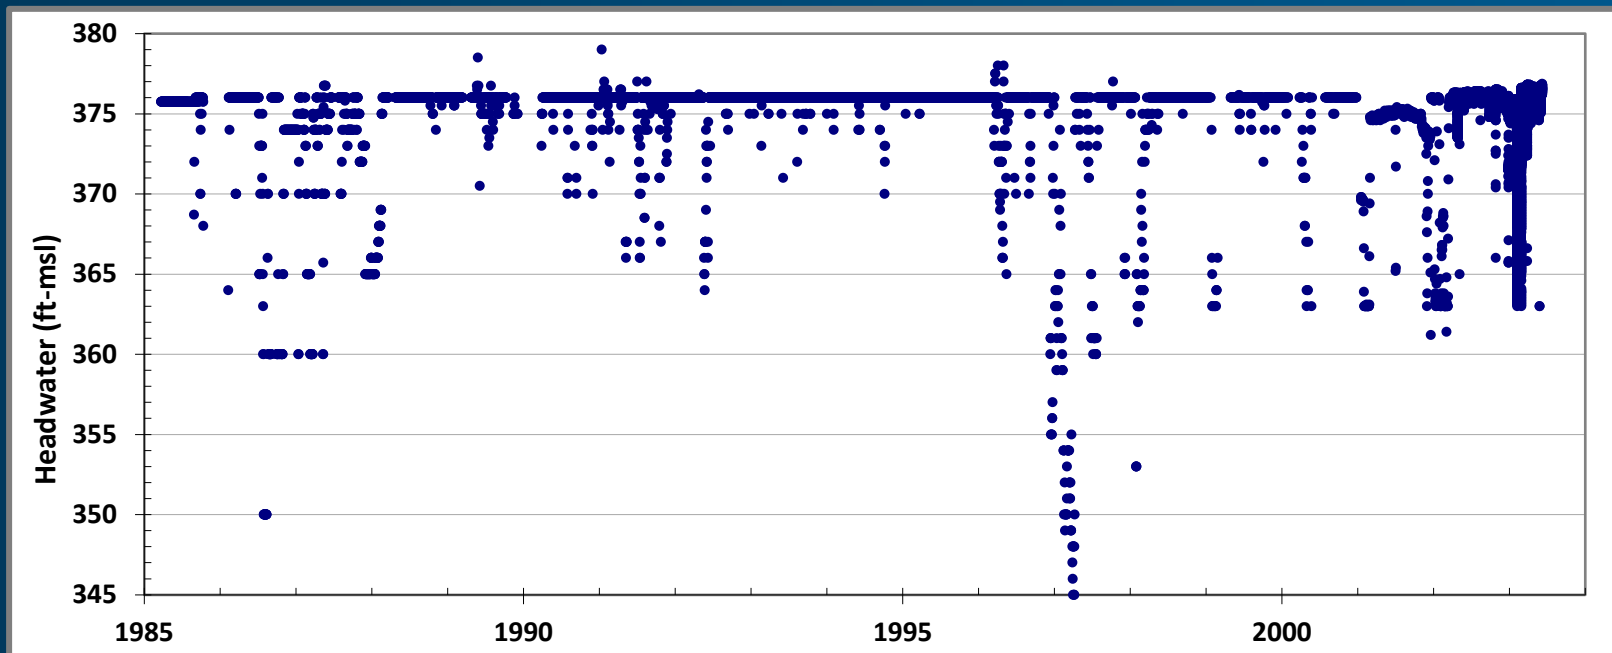
- Costly gate operations
- Unreliable lake level
- Environmental impacts
- Long-term stability

\*20% of lake level readings are below normal pool. Approximately 2.8 years of low lake levels over the past 20 years.

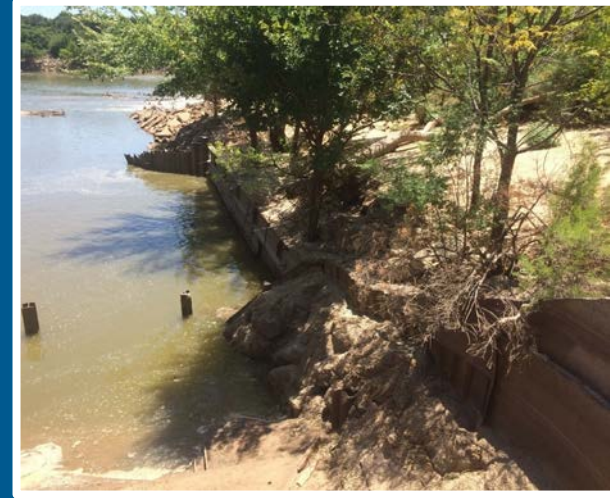
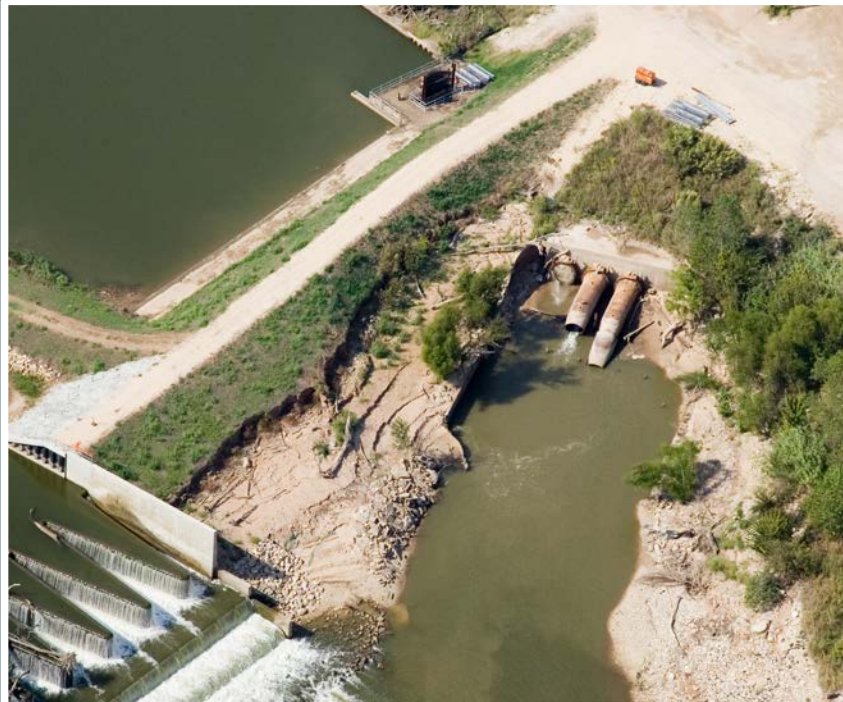
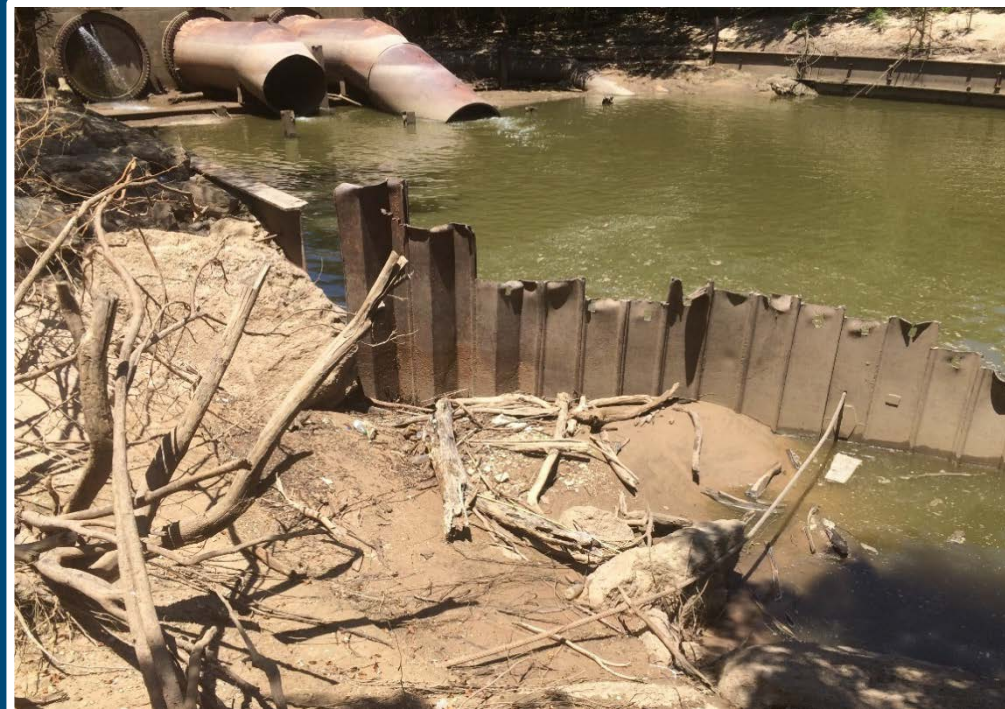
- 2007: TCEQ recommended monitoring until permanent repair is implemented
- 2014: Existing sheetpile condition noted to be worsening
- 2016: FNI evaluated the existing condition of the embankment and earth retaining system

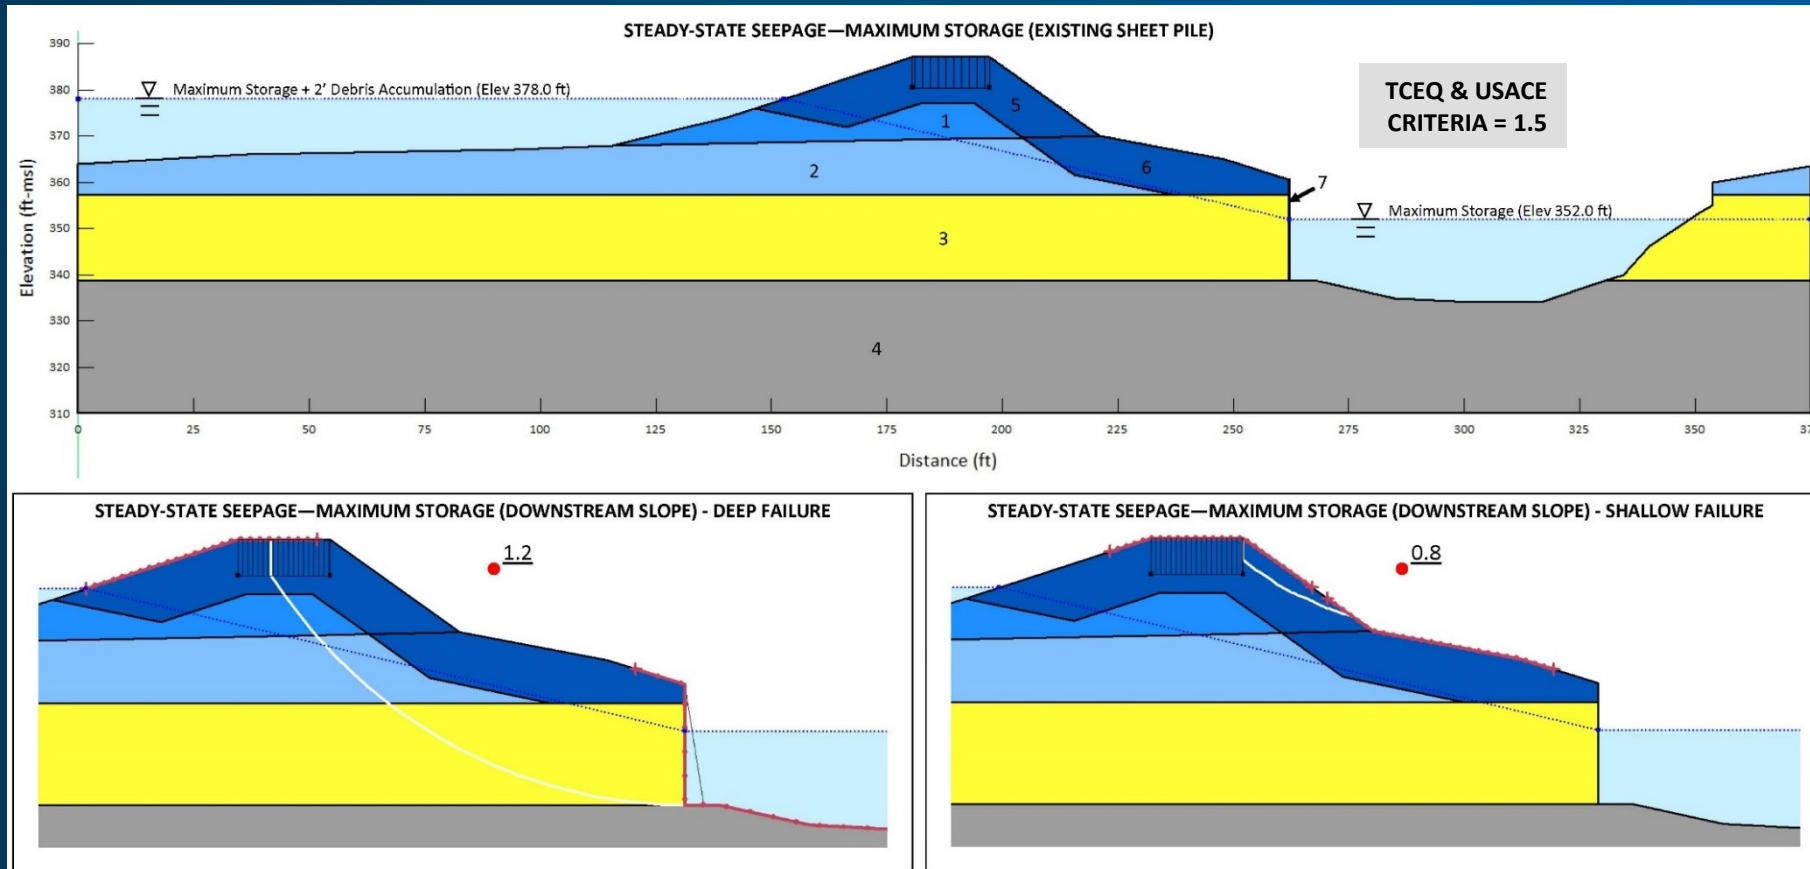
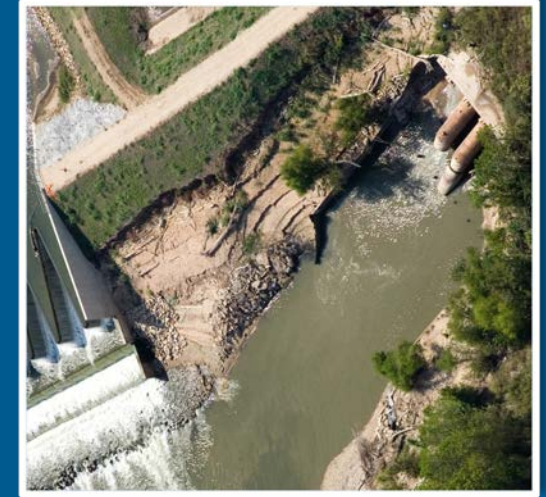
- Embankment downstream slope stability does not meet recommended safety factors

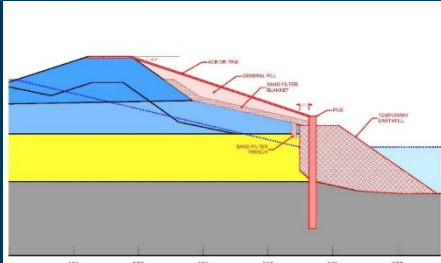
IN CHANNEL WITH 3:1  
FLATTENED SLOPE

- Secant pile repair options to stabilize embankment

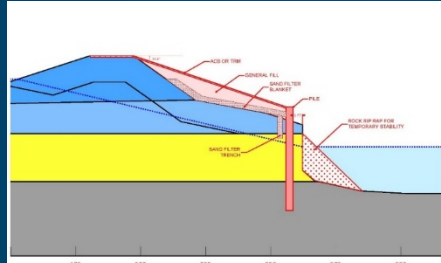
AT TOE WITH 2.3:1  
FLATTENED SLOPE

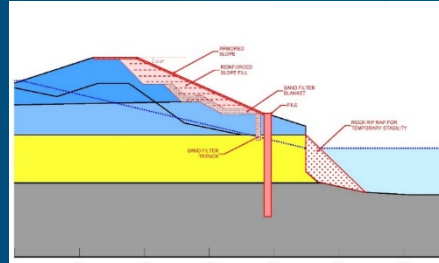
AT TOE WITH 3:1  
FLATTENED SLOPE

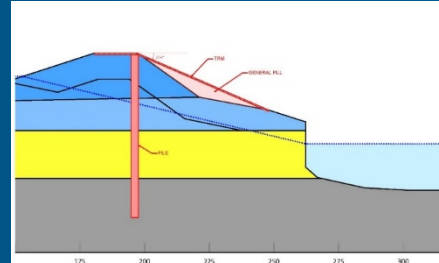
THRU CREST WITH 2.3:1  
FLATTENED SLOPE

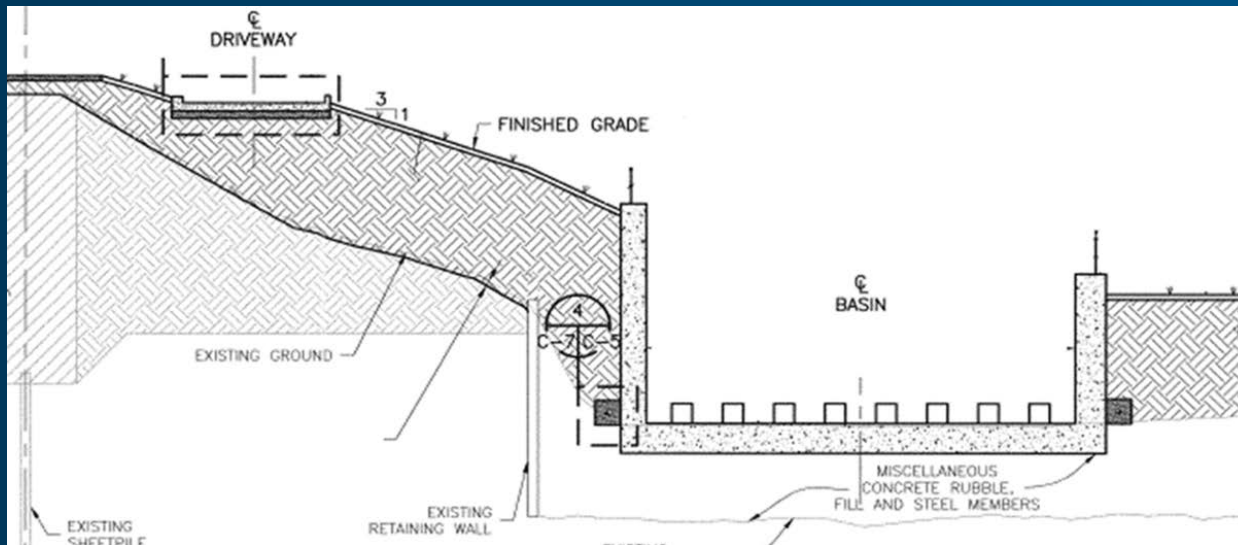
- Stilling Basin Addition
- Riprap Armoring
- Actuator Modifications
- Dewatering System Upgrades

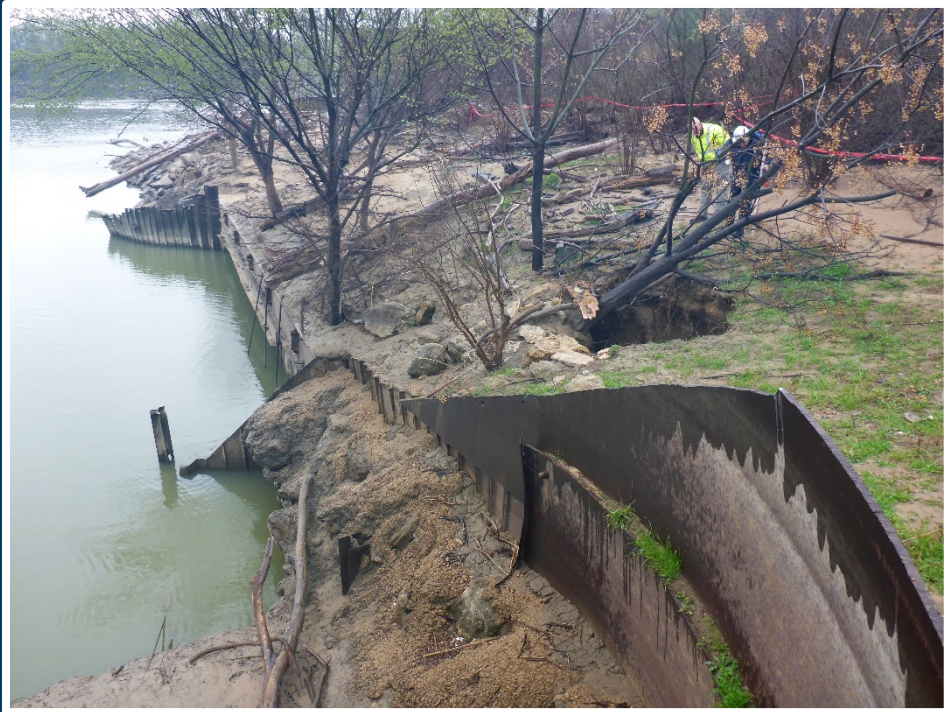
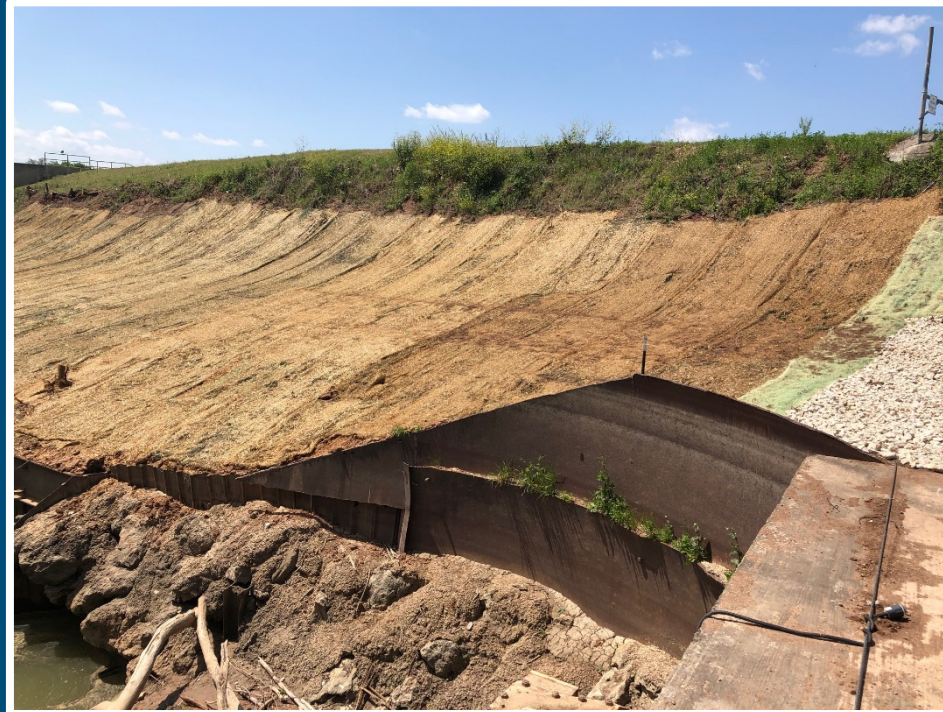
- 2019: City made temporary repairs to the worsening condition (sinkhole) of the embankment toe
