Date: **05/24/2023**
RFQ No: **2023-026**
Commodity: **North Interceptor Wastewater Improvements Phase 1a Ptoject**
Purchasing Agent: **Daryle Bullard**

Addendum No: 1

1. Geotechnical Reports

North Interceptor Sewer Waco, Texas

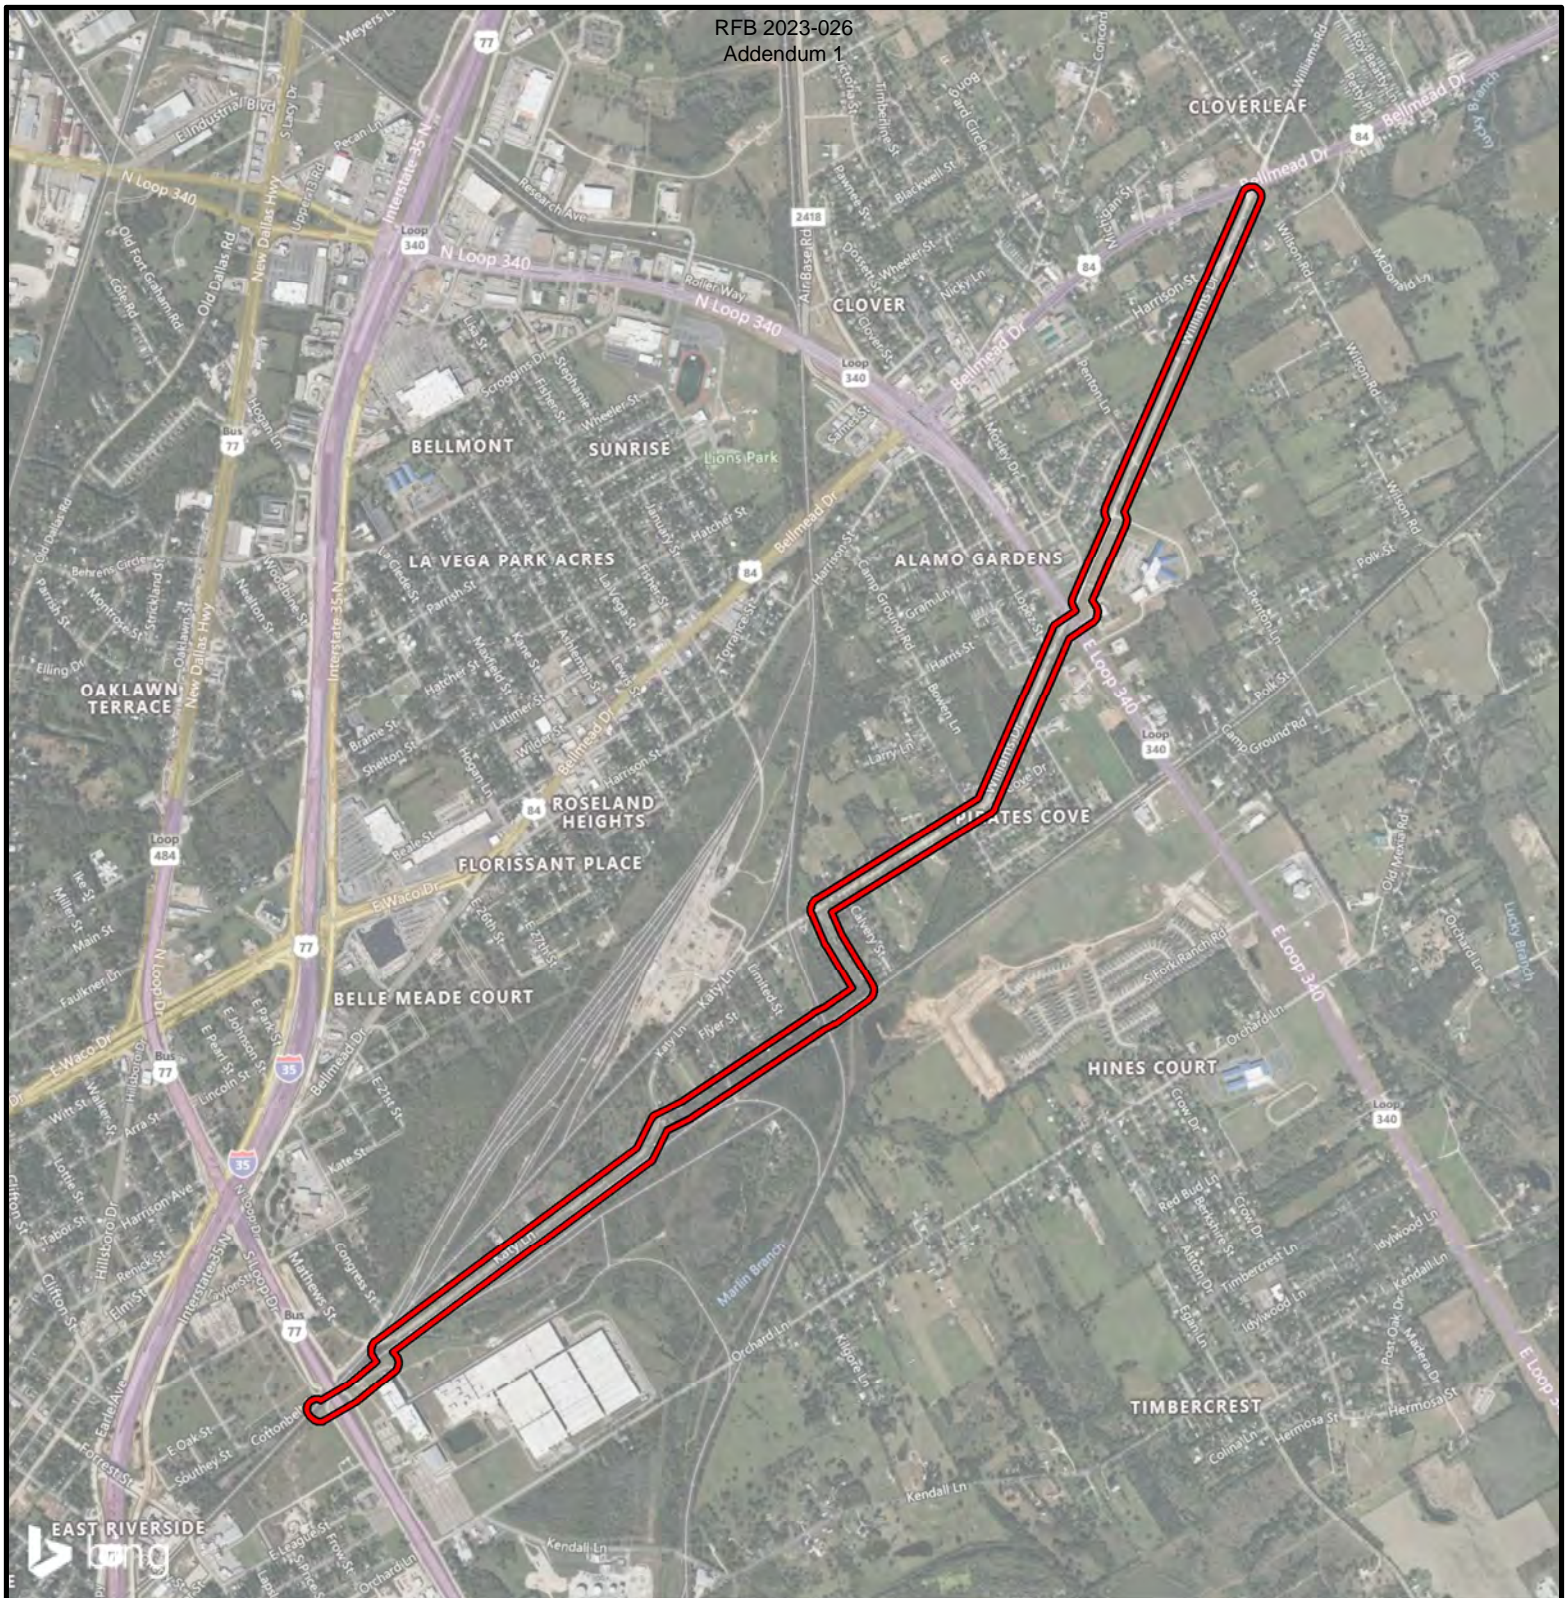
Figure 1
General Location Map

Integrated Environmental Solutions, LLC (IES), has been contracted by Walker Partners, on behalf of the City of Waco, to conduct the cultural resources review and coordination for a proposed wastewater improvement project encompassing an approximately 3.3-mile (mi)-long (80.8-acre [ac]) project corridor, or Area of Potential Effects (APE). The project will extend from southwest of the intersection of Coffee Street and U.S. Highway (US) 77 Business to northwest of the intersection of Williams Road and US 84 in the City of Waco, McLennan County, Texas (**Attachment A, Figure 1**).

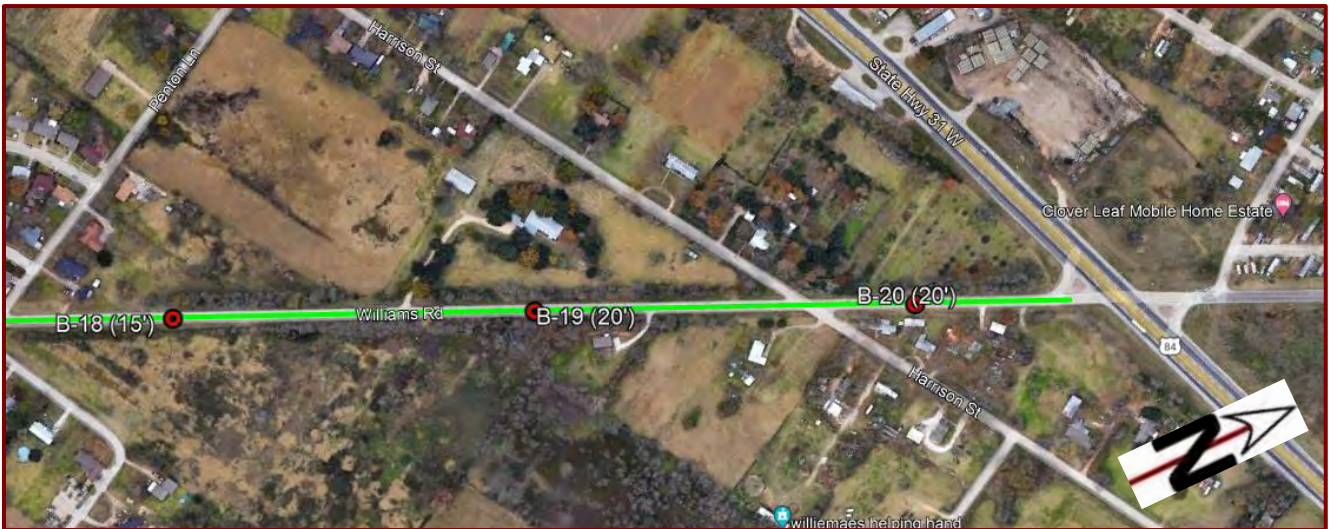
BORING LOCATION MAP

Boring Layout: The borings were staked in the field by LFE personnel using a sketch provided by Walker Partners. Boring locations are shown on Plates 1 and 2 in the Appendix.
