# LAKE BRAZOS DAM

## ENGINEERING SERVICES

Presentation to City Council

November 19, 2019

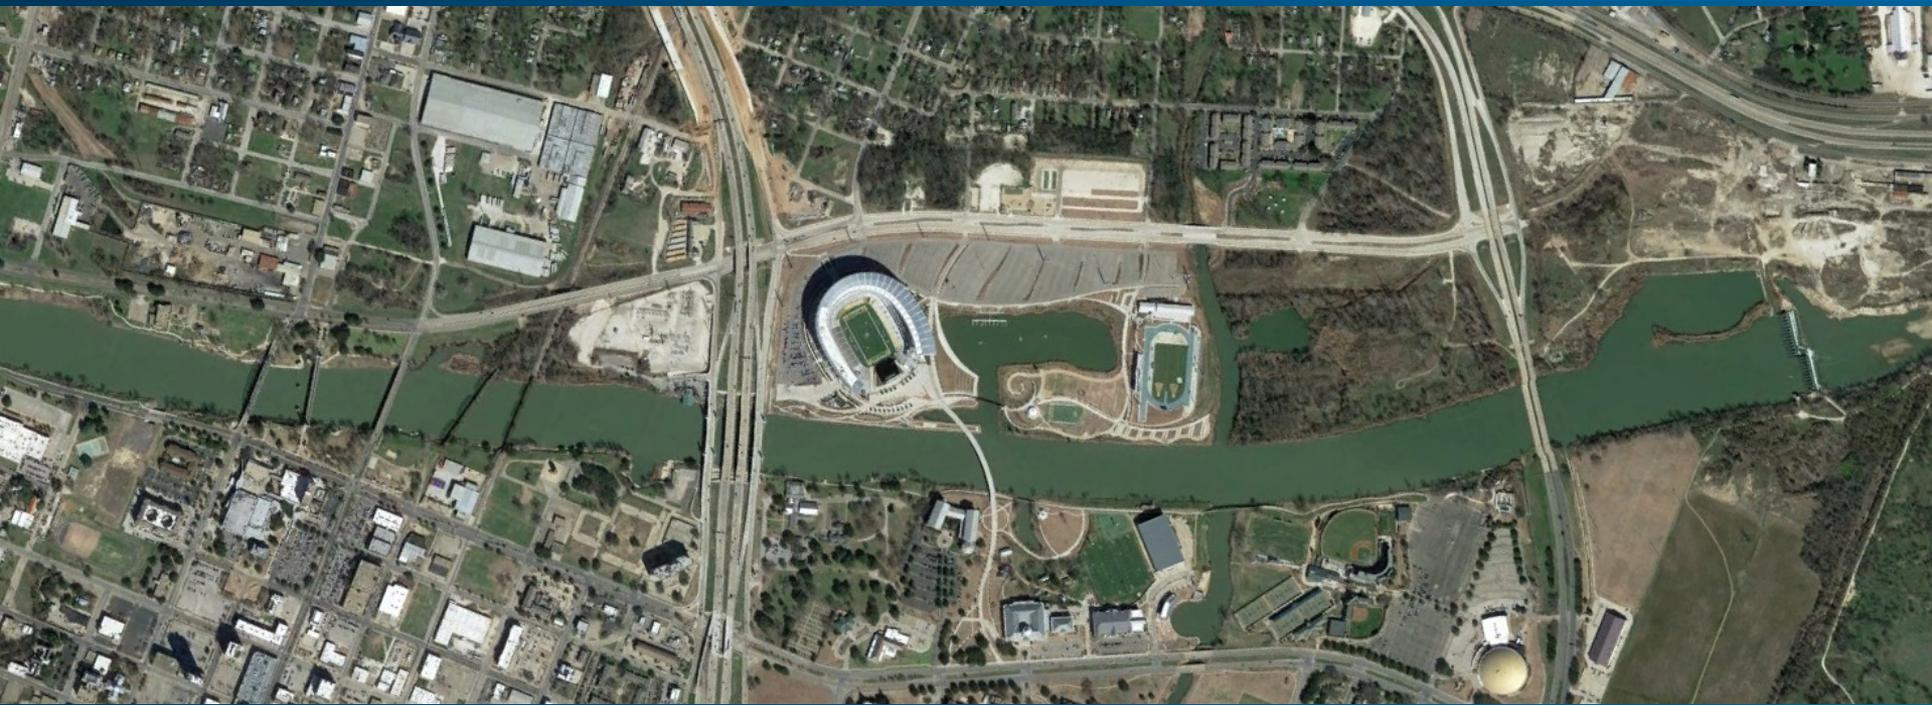
# RISK OF FAILURE

- *Significant risk* of failure of the embankment
- Failure would result in loss of the reservoir
  - Dam impounds the City's oldest water right
  - Amenity: Riverwalk and Baylor stadium
